Home Inspection for:
JLNR, LLC
3550 NW 8th AVE. Apt. 813
POMPANO BEACH, FL. 33064

INSPECTION # 170111
DATE: JAN/11/2017

INSPECTION DOCTOR
277 SW 159th Ter, Sunrise, FL. 33326
contact@inspectiondoctor.net

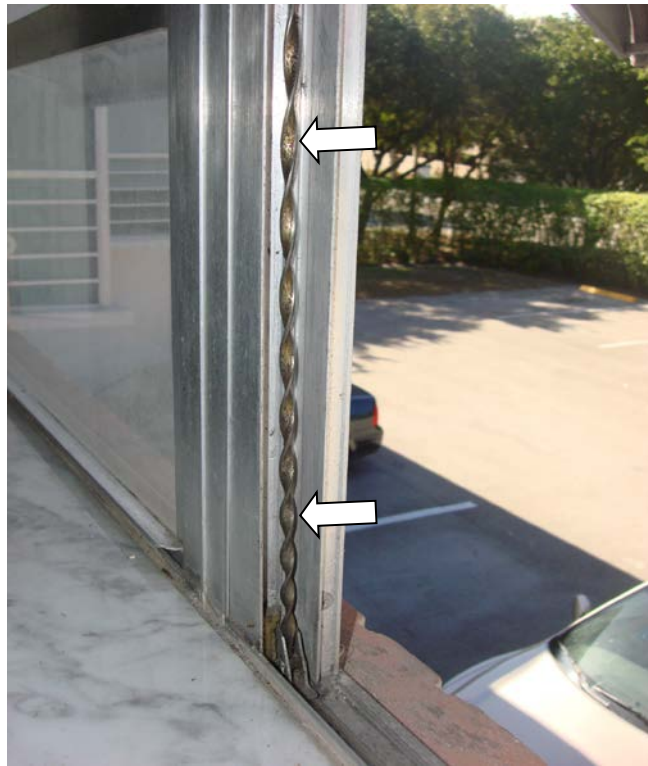
EXHIBIT 1

- 1.- IN MASTER BEDROOM, WINDOW'S RIGHT PANEL CANNOT BE HELD OPEN, ITS OPENING MECHANISM IS DAMAGED (EXHIBIT 1)**
- 2.- IT'S RECOMMENDED A GENERAL MAINTENANCE TO ALL WINDOWS IN THE PROPERTY, THEY ARE NOT EASY TO OPEN AND CLOSE**

REPAIR / MAINTAIN WINDOWS	\$400.00
PLUMBING REPAIRS (INCL. NEW DISPOSAL)	\$500.00
OTHER REPAIRS (INCL. REP. KITCHEN CABINET)	\$400.00
TOTAL	\$1,300.00

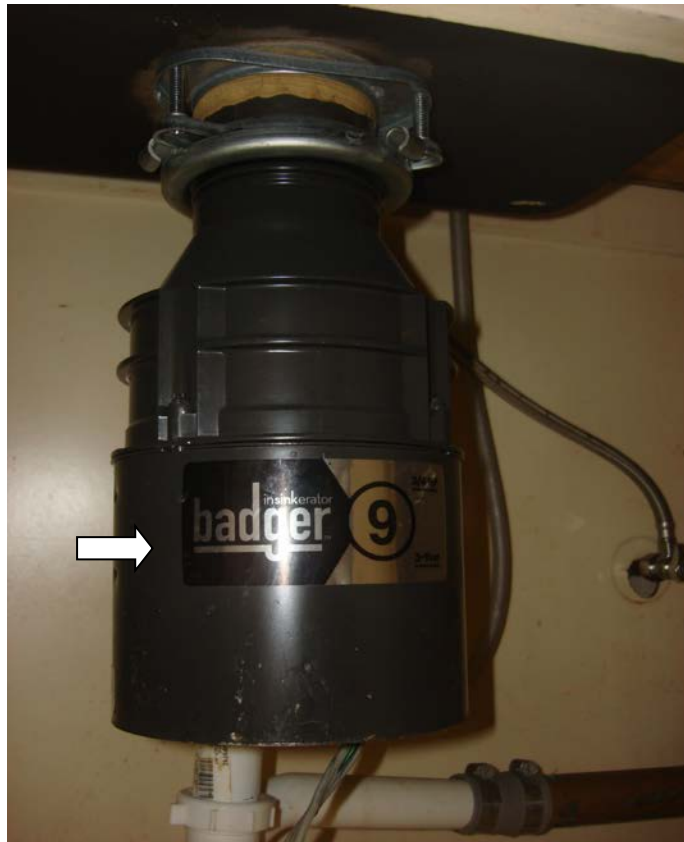
EXHIBIT 2

Remarks: **Most of plumbing components appear to be in good condition at the time of this inspection.****1.- DISPOSAL DAMAGED, NEEDS TO BE REPLACED (EXHIBIT 2)****2.- IN KITCHEN, THERE IS A LEAK UNDER THE SINK, THE CABINET BELOW HAS BEEN DAMAGED DUE TO WATER (EXHIBIT 3)****3.- FAUCETS OF SHOWER/TUB ARE LEAKING WHEN OPEN, WE STRONGLY RECOMMEND TO CHECK FOR INTERNAL LEAKS (EXHIBIT 4)**

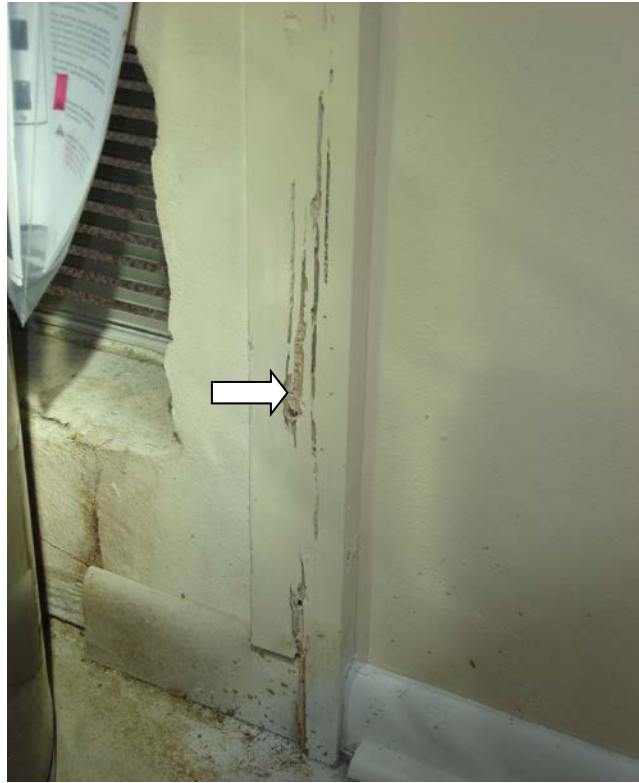
EXHIBIT 5

1.- THERE WERE SIGNS OF TERMITES AT THE MOMENT OF THIS INSPECTION. A PIECE OF WOOD INSIDE CLOSET OF SECOND BEDROOM HAD DAMAGE DUE TO SOME WDO, POSSIBLE TERMITES. WE ARE NOT A WDO CERTIFIED, SO WE RECOMMEND TO HIRE A CERTIFIED COMPANY TO DETERMINE IF THERE ARE LIVE WDO ORGANISMS (EXHIBIT 5)

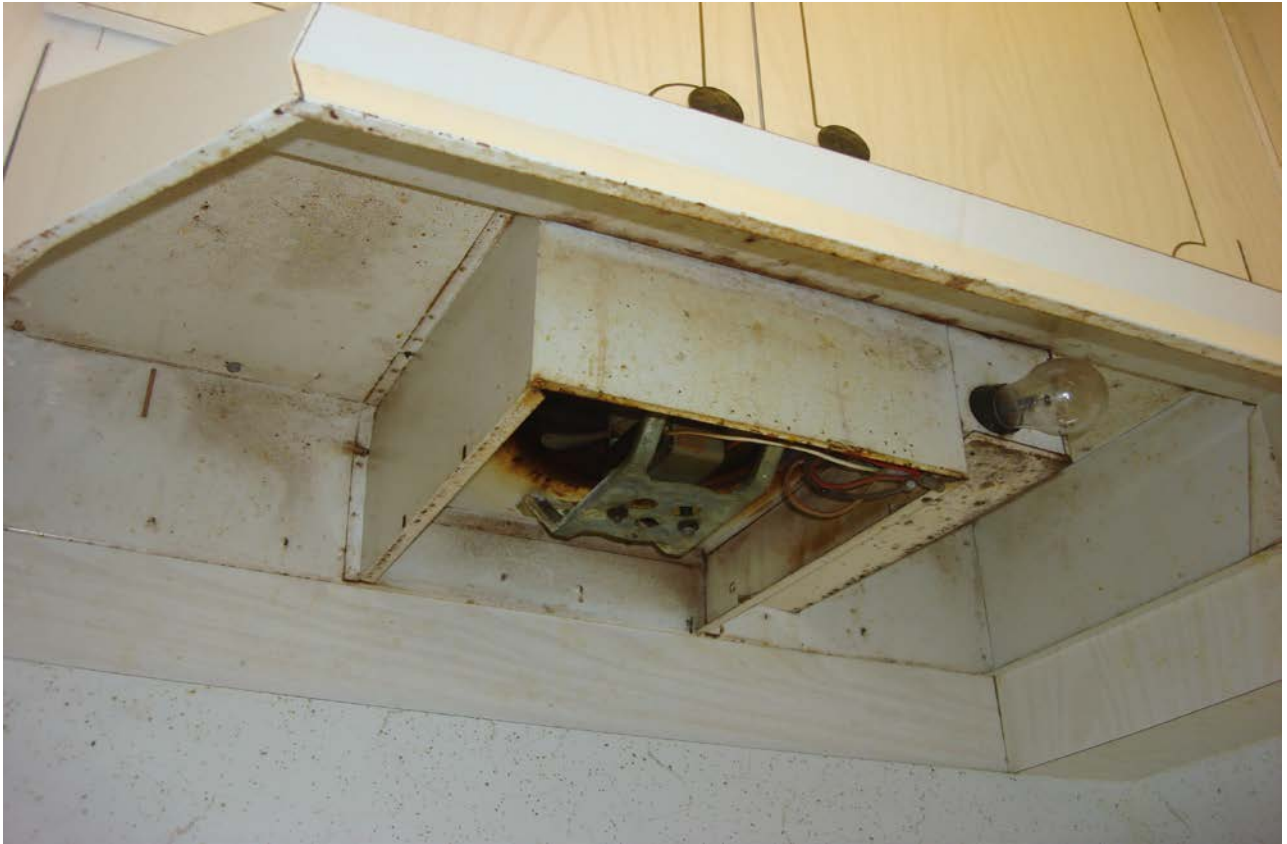
EXHIBIT 6

2.- THE RANGE HOOD HAD NO FILTER INSTALLED (EXHIBIT 6)
